State of California — The Resources Agency  
DEPARTMENT OF PARKS AND RECREATION  
**PRIMARY RECORD**

Page 1 of 1 \*Resource Name or #: 912-914 12<sup>th</sup> Street

P1. Other Identifier: Hotel Ridgeway, Hotel Del Paso

b. Address: 912-914 12<sup>th</sup> Street City Sacramento Zip: 95814

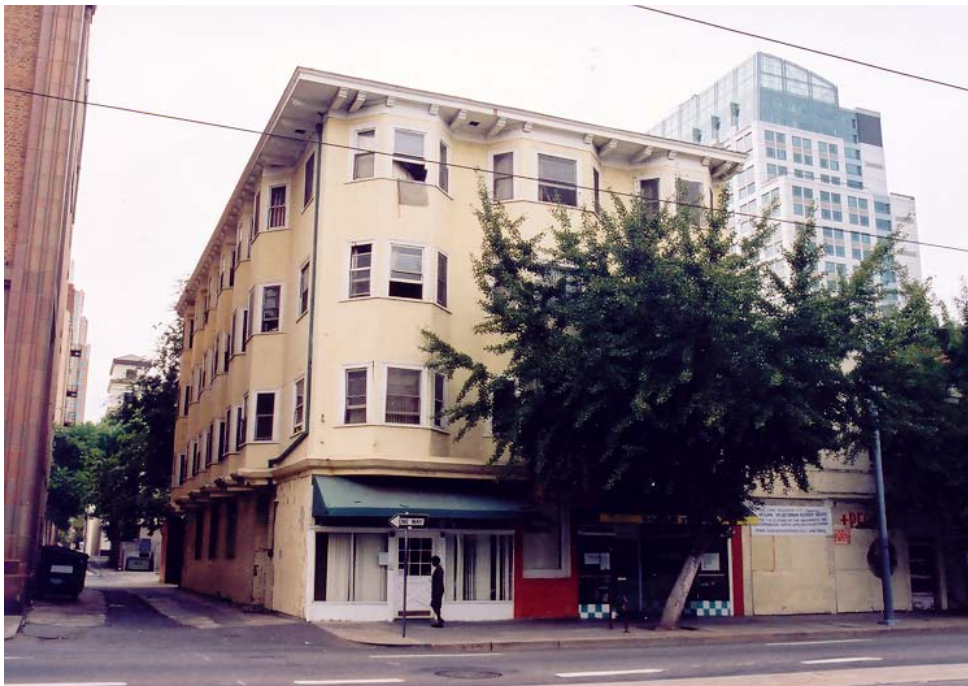
**P5b. Description of Photo:**

The hotel structure reflects minor Craftsman Style influences. The building is four stories in height and has been re-surfaced with stucco. The south and east elevations contain projecting angled bays continuous from the roof to second floor on the three stories above the street level. The bays each contain three windows, each with wood sash and double hung windows. Wood beams beneath the soffit support the roof overhang. The street level contains two shops; the Orient Express with a recessed entry and show windows above a checkered base, and the recessed entry to the hotel, flanked by show windows. An awning covers the transom or clere story area above the windows.

View of east façade on 12<sup>th</sup> Street and south elevation with bays on the alley, View to northwest.

The Ridgeway Hotel will need to be re-evaluated, it could become eligible for individual listing if it is restored to its former appearance.
